# **H**AZARD **A**LERT **L**IVE **T**OMORROW

## **Near Miss/Serious Electrical Accident**

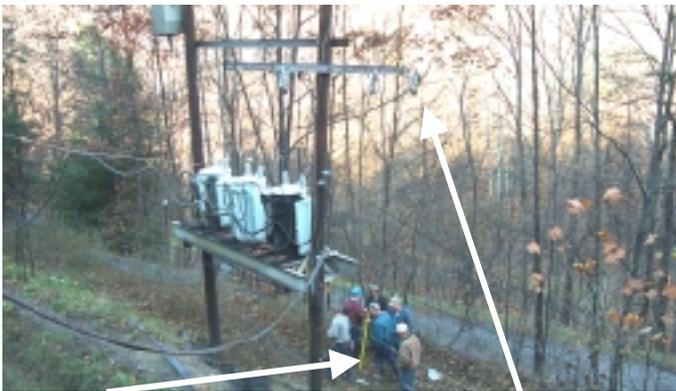
Location Of The Victim

Disconnect – The Victim Was Changing

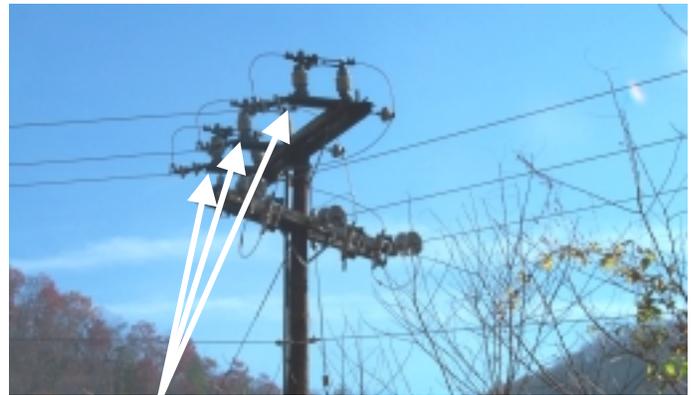
Disconnects – Victim Failed To Pull Correct Disconnects

1. **Disconnecting devices shall be de-energized, locked out and suitably tagged by the person performing such work.**
2. **All high voltage circuits shall be grounded before repair work is performed.**
3. **Multiple high voltage circuits fed from a common substation shall be marked for identification to ensure the correct circuit has been de-energized.**
4. **REMEMBER!! IF A CIRCUIT IS NOT GROUNDED - THEN IT IS NOT DEAD!**

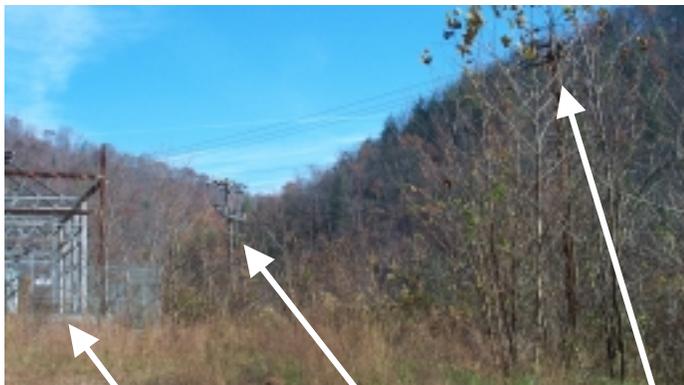
Common Substation

Fan Disconnects – Not Opened

Mine Disconnects – Opened

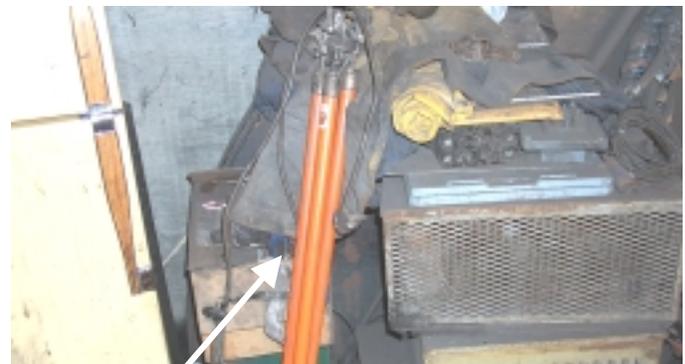
Grounding tree – victim failed to use (was available at the mine site).
